# Manhole Inspection Summary

Manhole # S55K\_\_009MH

Insp Date: **6/2/08 2:38 PM**

**Location** Address: **818 s conkling st**

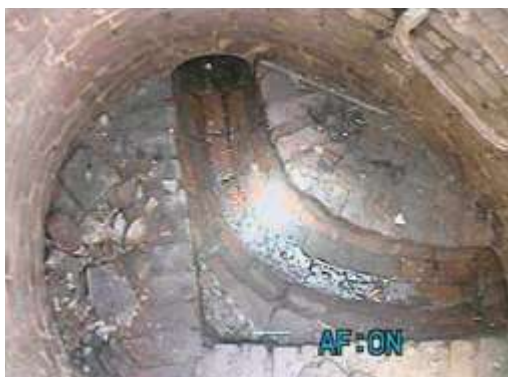
misc

debris

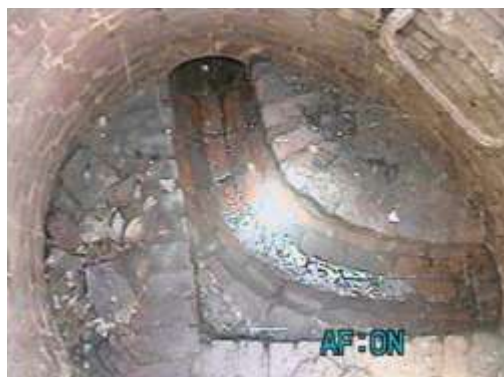
Defect 3

**Steps** Count: **1** Missing: **0** ☒ Corroded

corroded steps

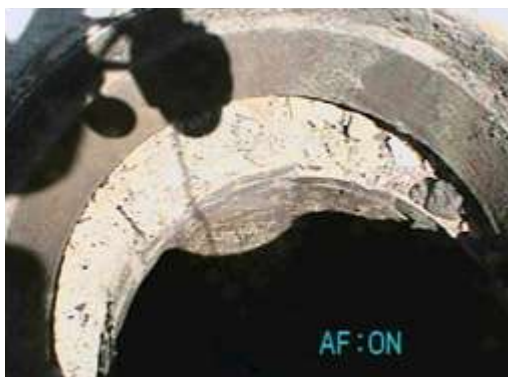
Defect 2

**Frame** Offset: **5** (in.) Condition: ☒ Sound ☐ Cracked ☐ Leaks

offset

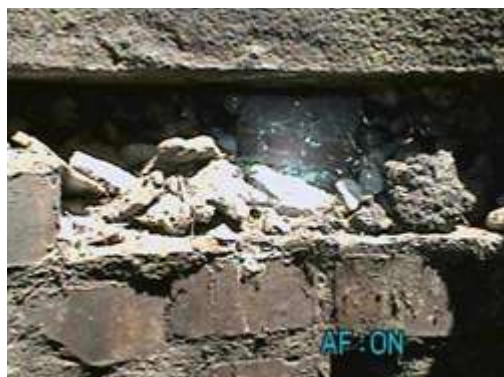
Defect 1

Condition: ☐ Sound ☐ Cracked ☐ Root Intrusion ☒ Loose Brick ☒ Deteriorated

corbel loose bricks,deteriorated,

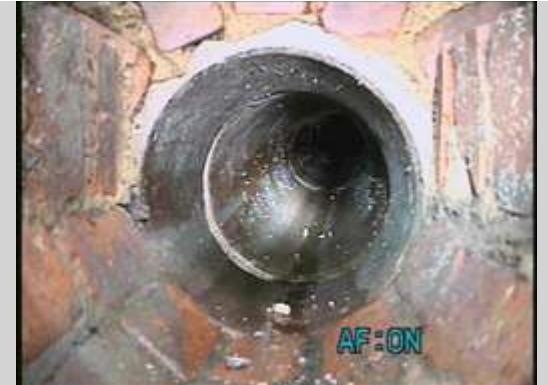
12 O'Clock Outflow

8 in. Circular Gravity Sewer  
Pipe Out @ 12 O'Clock

Invert Depth: 5.60 (ft.) Flow Characteristics: **Slow**

Infiltration: **None** Pipe Seal Cond: **Unknown**

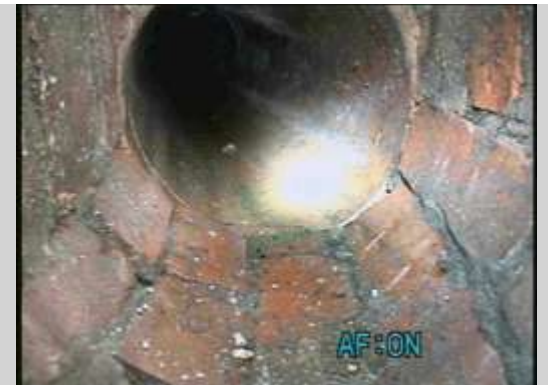
3 O'Clock Inflow

8 in. Circular Gravity Sewer  
Pipe In @ 3 O'Clock

Invert Depth: 5.40 (ft.) Flow Characteristics: **Slow**

Infiltration: **None** Pipe Seal Cond: **Unknown**
